MASONRY RESTORATION - Terra Cotta Restoration

PROJECT – SACRAMENTO CITY HALL

Description - Major restoration and preservation of Historic City Hall as part major new modern addition to replace tear down of 1950's addition

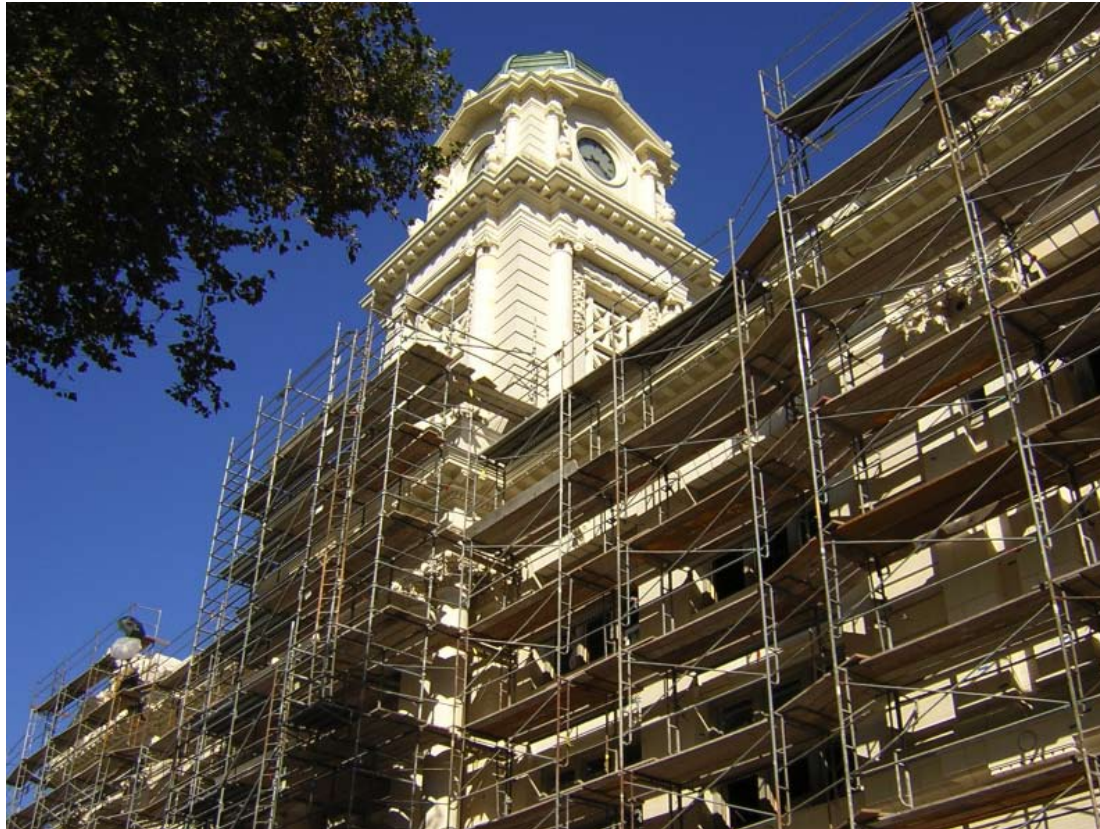
2002

Typical conditions prior to start of work

General deferred maintenance. Terra cotta glaze and bisque spalls, open mortar joints, cracked brick and terra cotta, accumulation of dirt and soiling at facade

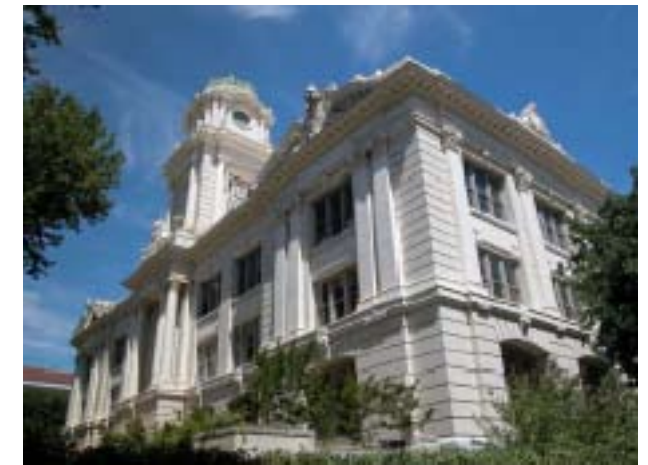
2004

Finished Openings

New bricks, terra cotta and stone were created to match missing elements lost during 1950's demolition for connecting tunnels. Lead joint caps were installed at parapet and water table joints

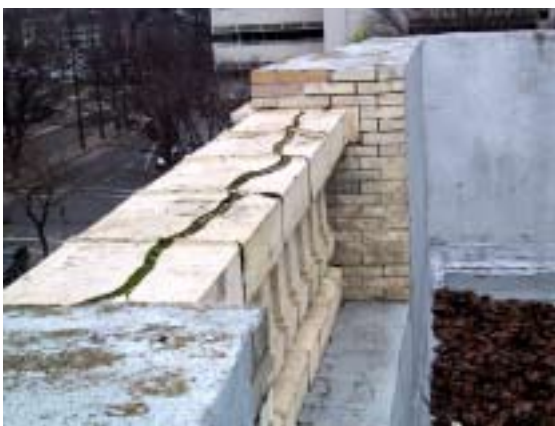
Quality Control Program

Working together with ARG, the Restoration Architects, Giampolini supervisors combed the façade, closely inspecting every square inch. All authorized repairs were marked on the wall with blue tape and recorded on 'as built' drawings. This process created an efficient means to visually communicate the work plan to crews. Upon completion of the work supervisors again combed the façade with ARG to QC final results.

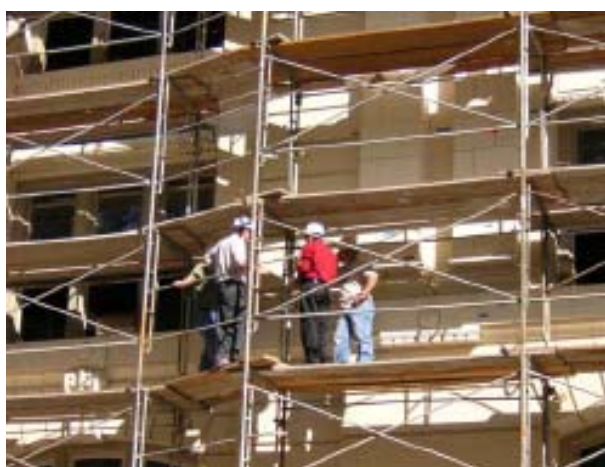
Terra Cotta

The terra cotta was completely disassembled, marked and cataloged to identify original locations. They would be reset in their original location. New blocks were ordered where originals were fractured beyond repair.
